Tree Preservation Report

For: Yorba Villas Residential, Chino

APNs 1013-211-21 and 1013-211-22

Prepared by: **Greg Applegate, ASCA**
Arborgate Consulting, Inc.
1131 Lucinda Way
Tustin, CA 92780
714/ 731-6240
email – greg@arborgate.occoxmail.com

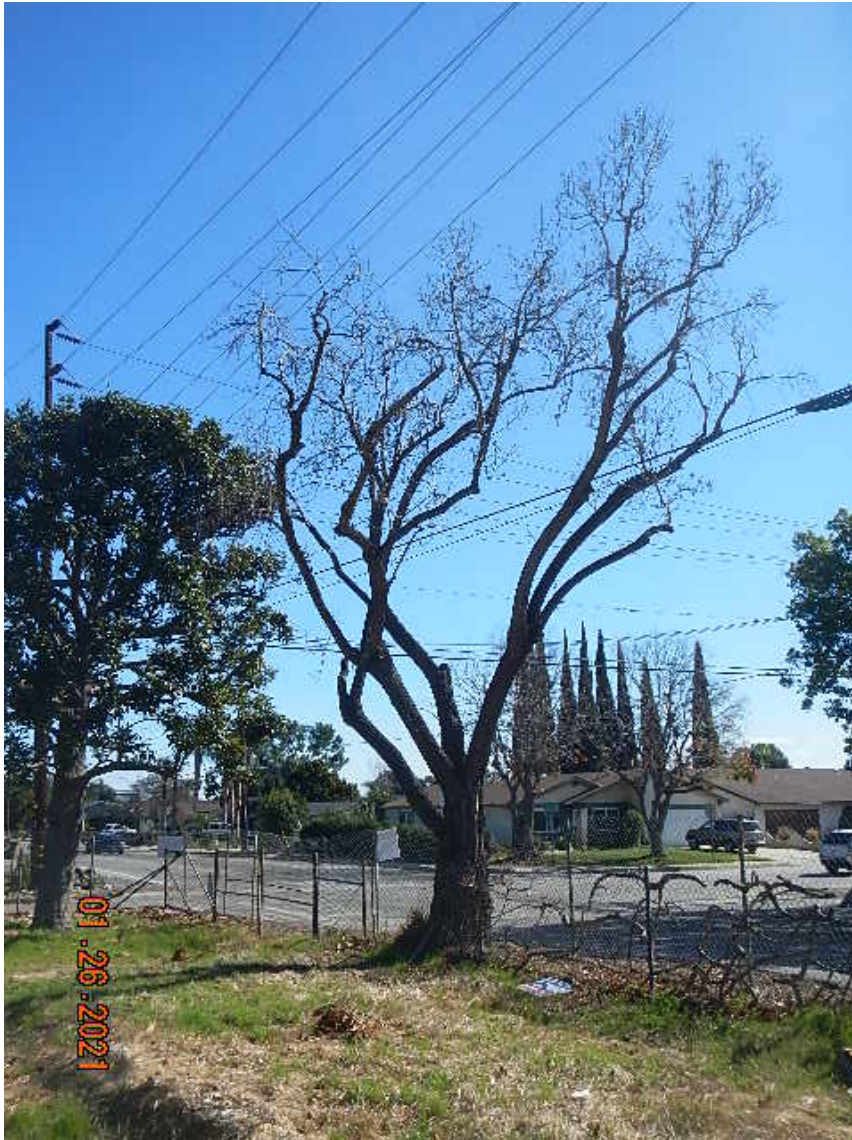
#1 Walnut

Tree#	Species	DBH	Ht.	Wd.	Health	Structure	Root cond	Comments
1	Juglans regia	26	30	32	D	D	Covered	Cod Db Hd under wires
2	Magnolia grandiflora	24	30	30	B	C-	okay	Hd Lt under wires
3	Morus alba	28	40	40	D	D	okay	Dk brk epi
4	Citrus limon	7.6 @ 3'	20	24	C	C-	fill	Sp wilted Xing
5	Washingtonia X 'Filabusta'	26	30	14	C-	B	fill	diamond scale
6	Washingtonia X 'Filabusta'	28	34	12	C	A	okay	diamond scale
7	Eucalyptus nicholii	24	40	38	C	C	okay	Cod inc Sp
8	Thuja orientalis	8" @ 1'	15	10	B	C	Covered	Cod inc OL
9	Afrocarpus falcatus	20	45	30	B	C-	Inj Sh	Cod topd Tinj
10	Afrocarpus falcatus	19	45	35	B	C-	okay	Cod Hd topd Tinj

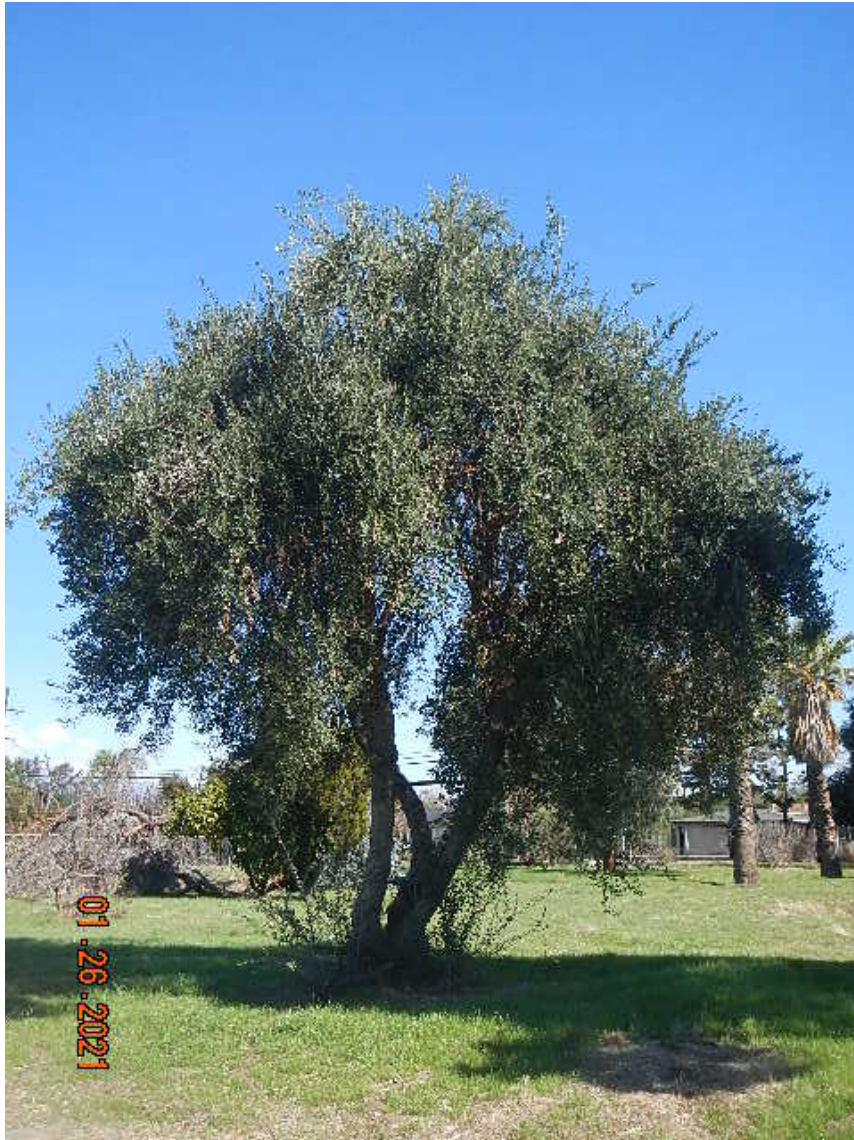
#11 Olive

Tree#	Species	DBH	Ht.	Wd.	Health	Structure	Root cond	Comments
11	Olea europea	12+10+8	28	34	B	C-	okay	Hd Dk epi
12	Juniperus c. Torulosa	13+14+13	28	34	B	C	fill	Cod inc OL Xing
13	Xylosma senticosa	13+13 @ 2'	22	30	B	C-	Covered	Cod FC OL OP DL
14	Cereus repandus	18"b	15	12	A	B	Sh	mBrk
15	Schinus molle	40	45	50	C	D-	Dk	TDk SDk BDk splitting
16	Prunus caroliniana	12	18	14	D	D	Covered	Db under wires
17	Prunus caroliniana	16	26	30	D	D	Covered	Db under wires
18	Sambucus mexicana	11+13	26	32	D	D	okay	Cod brk Db under wires
19	Phoenix canariensis	28	60'th	24	C	B	okay	T-bow Mg def, weak new fronds
20	Eucalyptus globulus	41	70	60	C	C	Covered	mDb DL CrS tortoise beetles
21	Ailanthus altissima	4+7+5+6+4	50	75	B	D	Covered	Thicket both sides of fence
22	Fraxinus velutina	24	40	50	B	D	okay	Cod CrS Xing
23	Ailanthus altissima	13+14	50	35	B	D	okay	Cod inc brk
24	Fraxinus velutina	40	45	50	B	D	okay	Cod inc Xing Dk 2long

If any trees can be retained, only trees #2, 9, 10, 11 and 13 are recommended for preservation. The following chart provides an minimum tree protection zone for the routing of underground utilities, grading, and for other design considerations. These recommendations are also discussed in the ISA publication “Trees & Development: A Technical Guide to Preservation of Trees During Land Development”, by Nelda Matheny & James Clark, 1998, Pg 74.

Tree#	Species	DBH	Ht.	Wd.	Health	Structure	Root cond	Clearance radius
9	Afrocarpus falcatus	20	45	30	B	C-	Inj Sh	20'
10	Afrocarpus falcatus	19	45	35	B	C-	okay	19'
2	Magnolia grandiflora	24	30	30	B	C-	okay	24'
11	Olea europea	12+10+8	28	34	B	C-	okay	16'
13	Xylosma senticosa	13+13 @ 2'	22	30	B	C-	Covered	16'

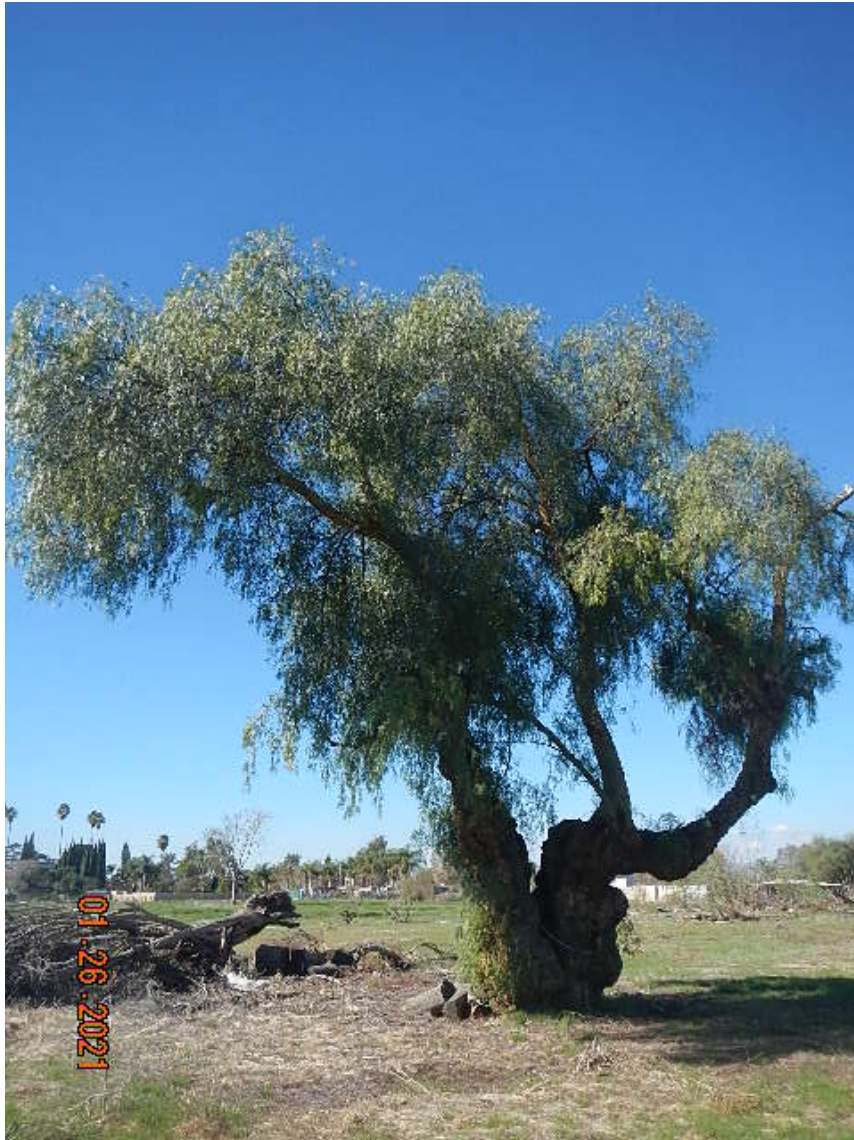
#15 California pepper

The walnuts are in fair to poor health and most were headed back or topped severely. Both ash trees are in good health but poor structural condition. The one California pepper is a hazard. The one blue gum is a hazard and being eaten by tortoise beetles. The other eucalypt, the willow-peppermint, is adequately healthy, but has a lot of included bark and is flat sided. It is also not very tolerant of root disturbance. Tree of heaven is a noxious weed from China and is somewhat out of control here. The one mulberry is severely decayed and has broken limbs. Citrus are not tolerant of root disturbance and seldom survive construction stresses. The one London plane was severely headed back and unattractive. Carolina cherries are only found under the power lines where birds drop seeds, and are in poor health with significant dieback. The Italian cypress has been limbed up too much and its trunk is being strangled by the ivy around it.

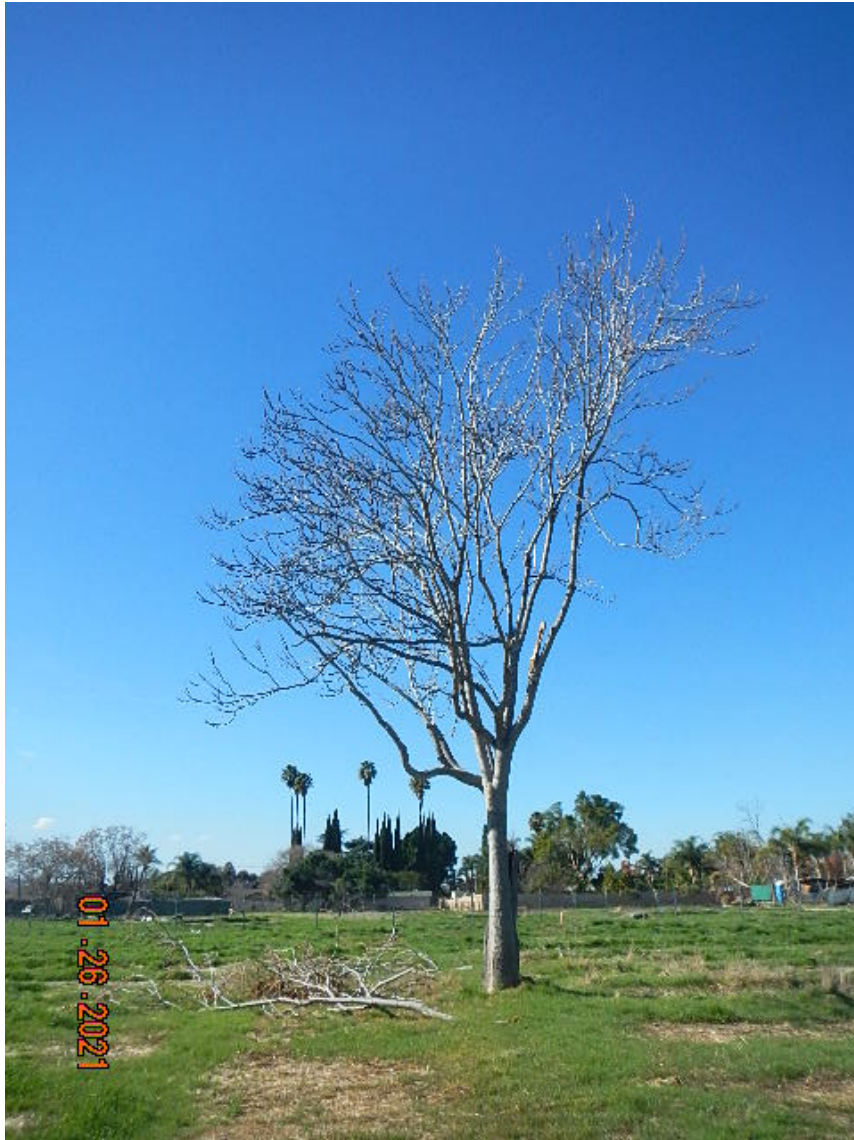
#23 Tree of heaven – note tear out on the right side of the trunk.

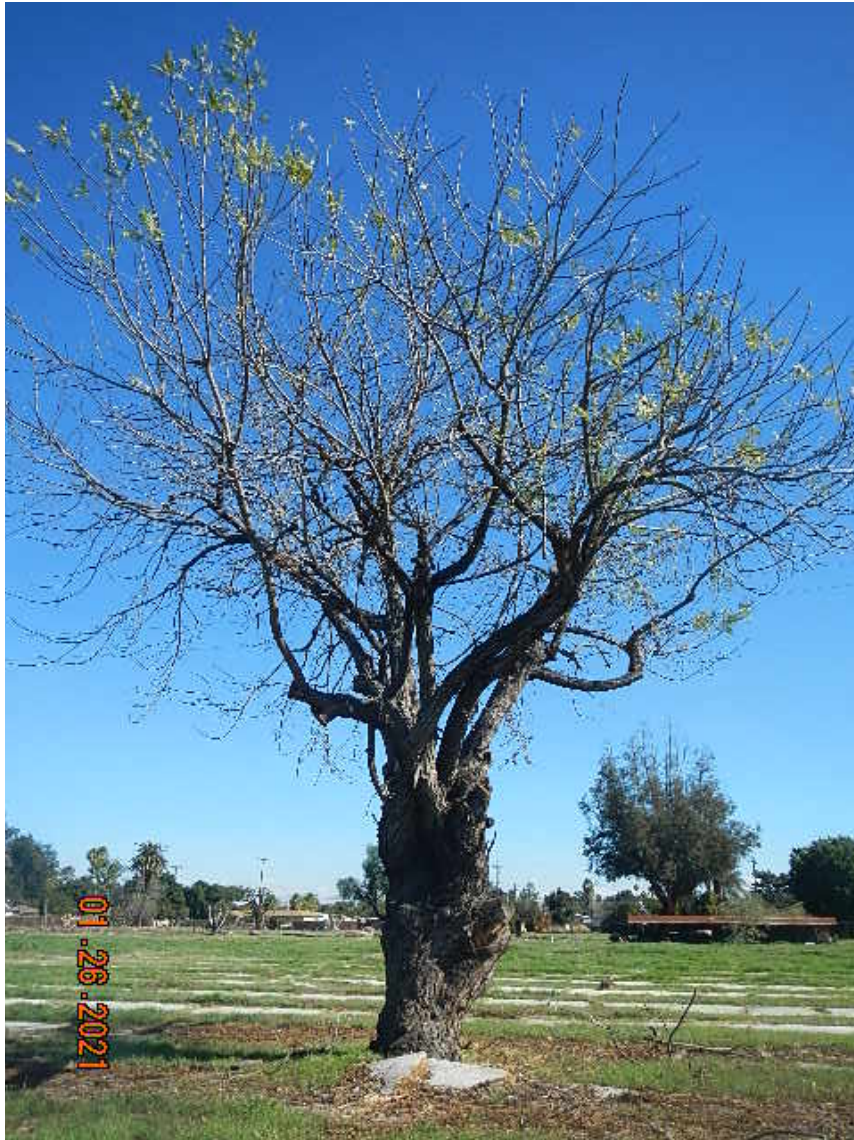
#25 Walnut

25	Juglans regia	42	45	50	C	D	1sRF	Cod inc Xing Dk
26	Juglans regia	30	50	60	C	D	okay	Cod Hd OL big limbs cut
27	Juglans regia	30" @ 3';	25	30	D	D	okay	Topd epi
28	Juglans regia	40	28	45	D	D	okay	Topd epi under wires
29	Ailanthus altissima	7+5	30	26	B	D	okay	Leans cod suppressed
30	Ailanthus altissima	7+5	22	24	B	D	okay	Leans cod suppressed
31	Ailanthus altissima	38"b	40	50	B	D	okay	Cod inc CrS under wires
32	Sambucus mexicana	30"b	25	40	B	C	okay	Cod inc by meter, under wires
33	Ailanthus altissima	14	30	35	B	D	okay	Leans 45° 1s cod

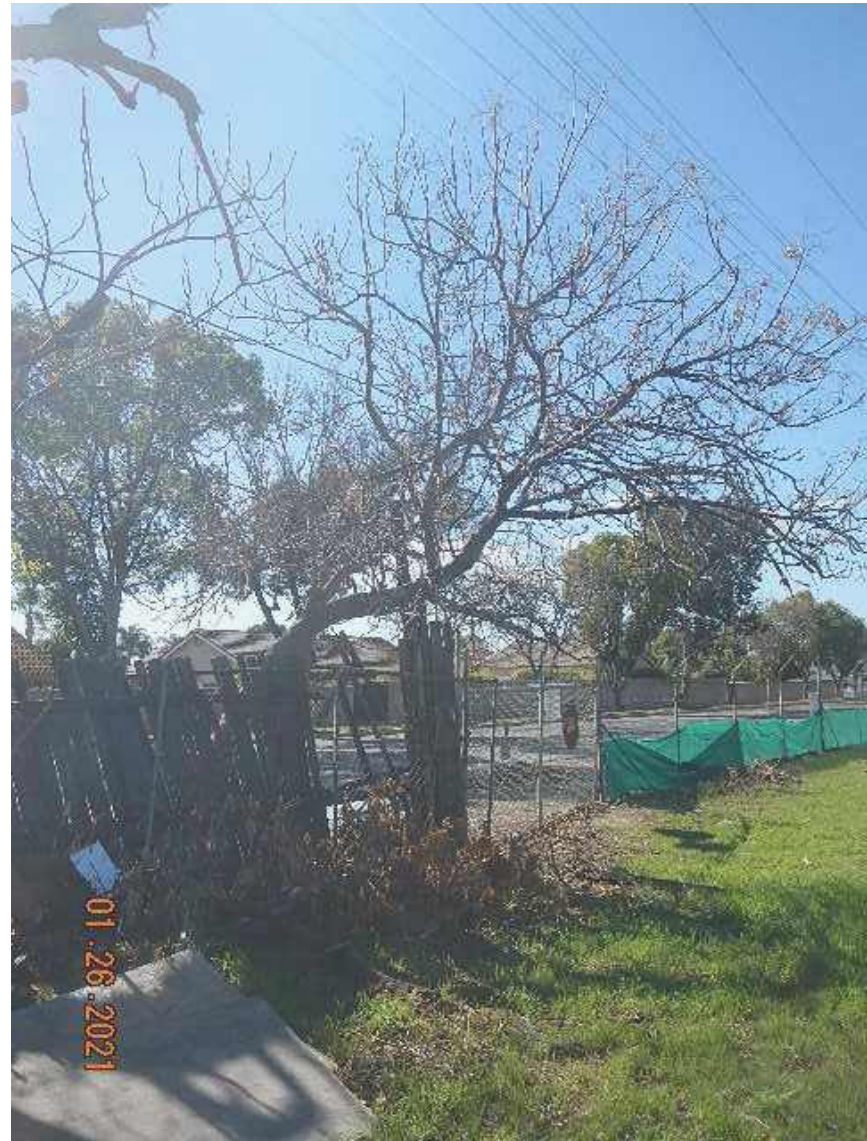
#31 Tree of heaven – note leaning trunk

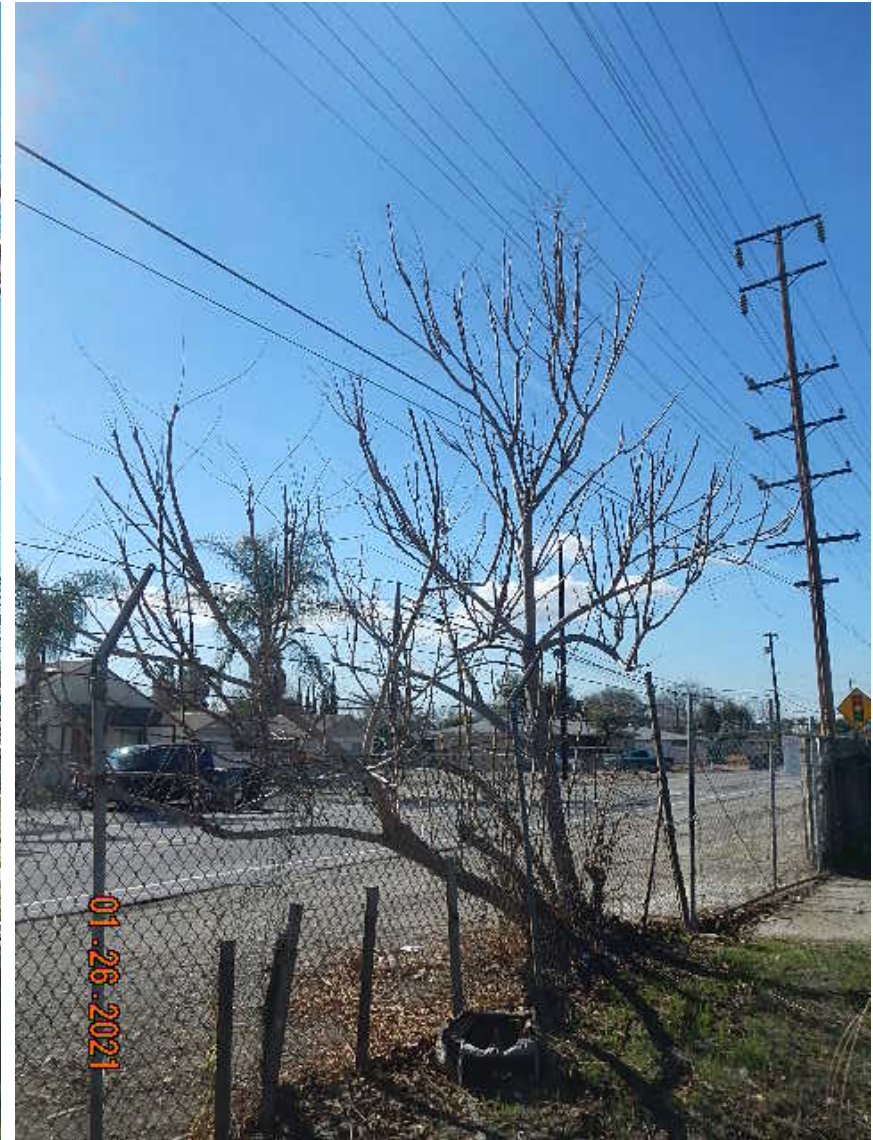
#34 Tree of heaven

Tree#	Species	DBH	Ht.	Wd.	Health	Structure	Root cond	Comments
34	Ailanthus altissima	5+4+3+3	20	20	B	D	Covered	Cod base 1s
35	Ailanthus altissima	6+6+5	25	18	B	D	Covered	Cod base 1s, tree fell on it
36	Washingtonia X Filabusta	24	50'th	14	B	A	okay	Long skirt
37	Washingtonia robusta	13	50'th	10	B	A	okay	Long skirt
38	Washingtonia robusta	14	70'th	10	B	A	okay	
39	Juglans regia	14	26	26	D	D	fill	Hd Db
40	Ailanthus altissima	15+13	40	24	B	C-	Covered	Cod inc
41	Ailanthus altissima	13	35	28	B	C	in fence	On PL Tinj cod inc
42	Ailanthus altissima	30" @ 1'	35	28	B	D	Covered	Cod inc brk
43	Ailanthus altissima	30"b	45	50	B	C	okay	Cod Xing
44	Washingtonia robusta	17	70'th	10	B	B	okay	Thin trunk
45	Cupressus sempervirens	7	35	4	B	D	Covered	T-gird by ivy OL
46	Platanus x Hispanica	25 @ 2'	32	30	C-	D	fill	Hd topd epi cod

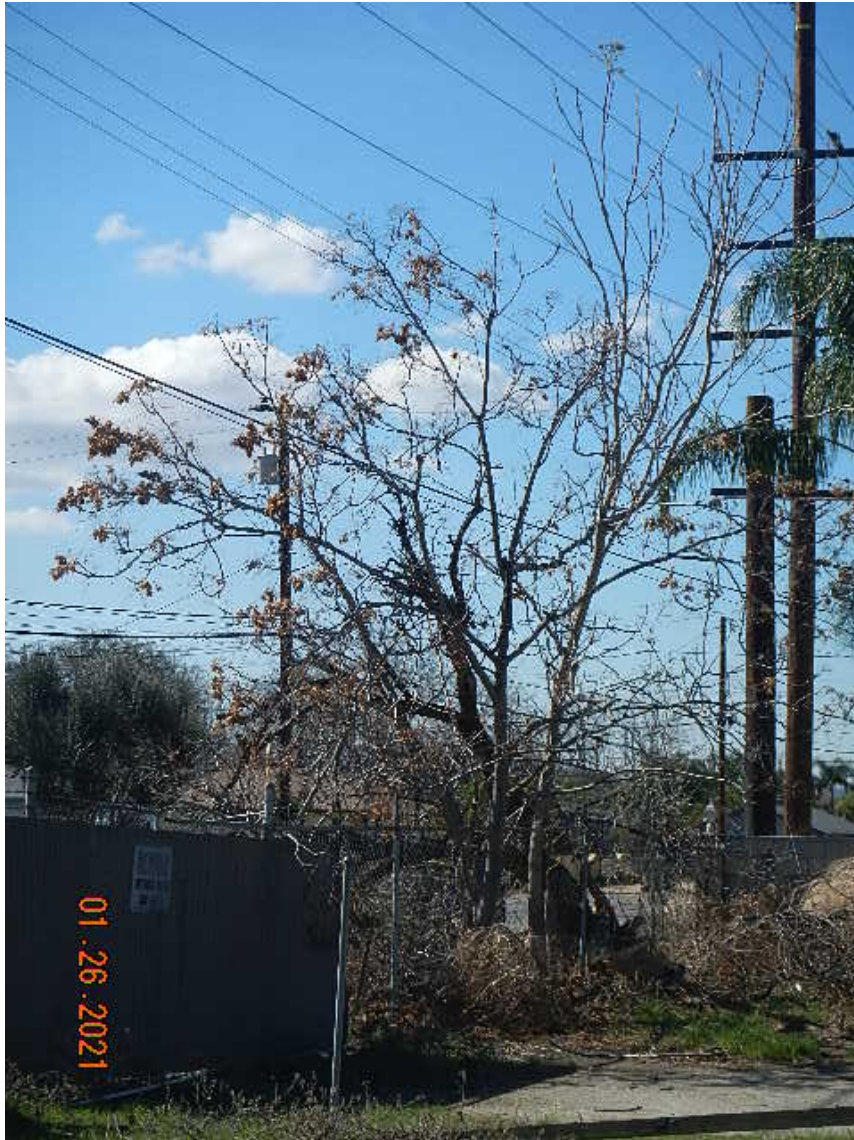
#35 Tree of heaven – note the tree that fell on it.
